Channel Modification For Fish Passage On Umatilla River

**Supplement to
Final
Report
1985**

CHANNEL MODIFICATION FOR FISH PASSAGE
ON
UMATILLA RIVER

William L. Sanguine, Geologist
U.S. Army Corps of Engineers
Building 602 City-County Airport
Walla Walla, Washington 99362-9265

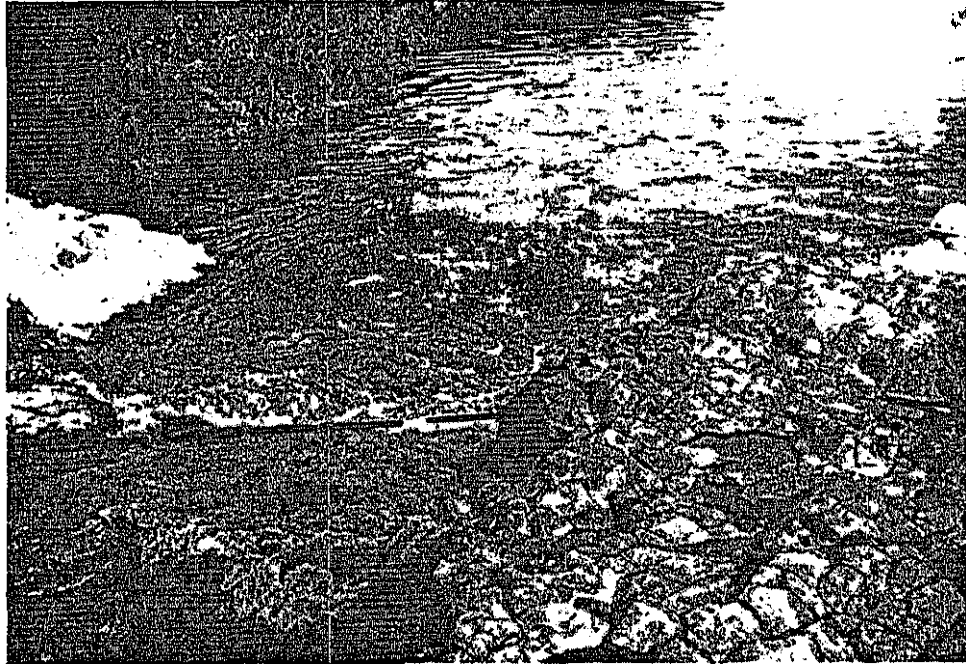
PHOTO 1: WEIR NO. 1 STA. 116+80 PRIOR TO CONSTRUCTION

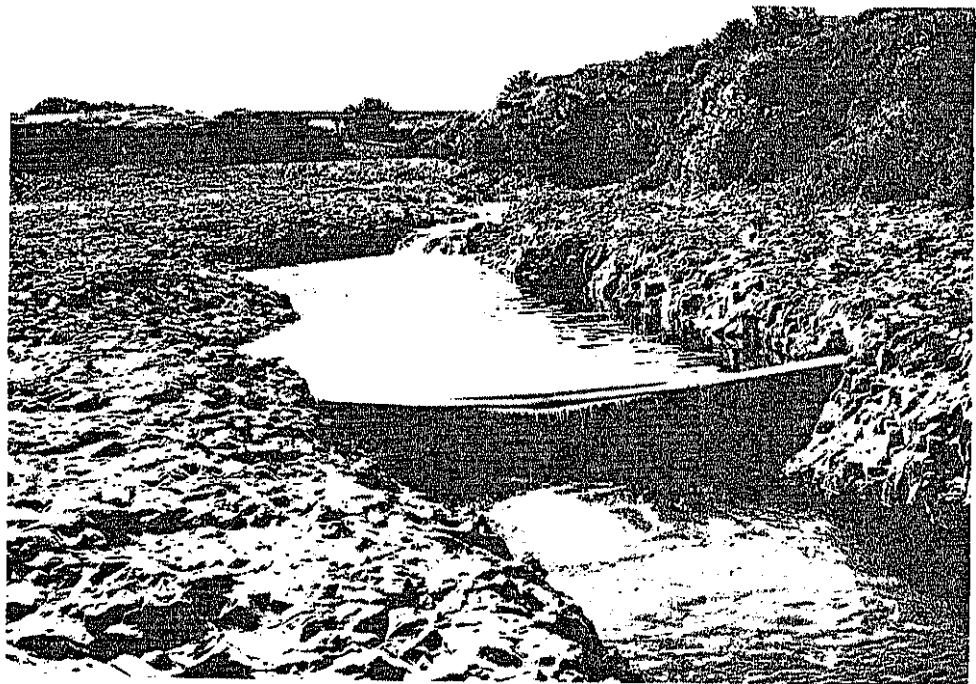
PHOTO 4: WEIR NO. 2 AS CONSTRUCTED

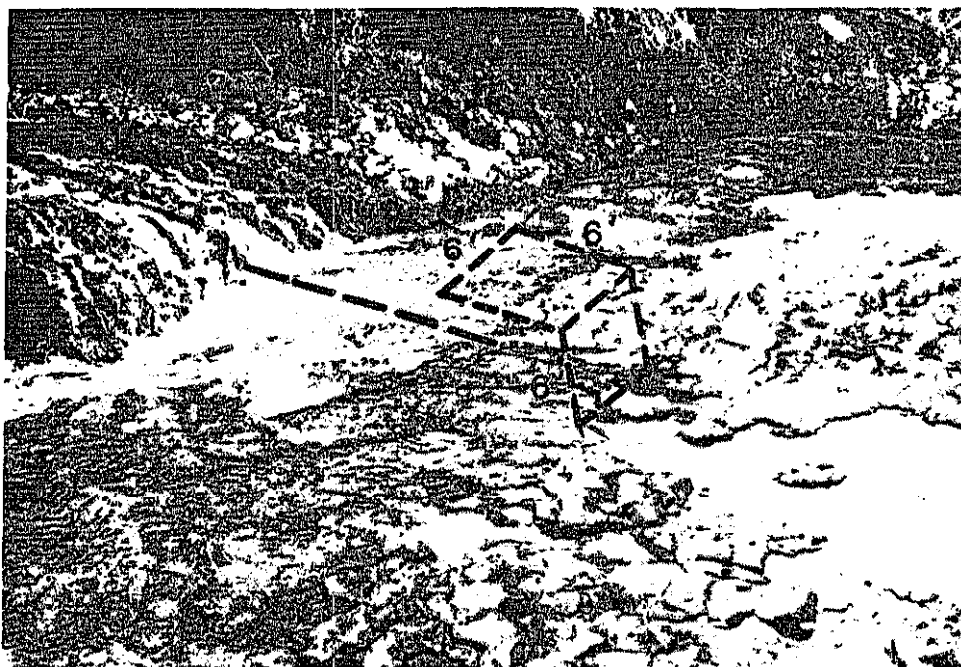
**PHOTO 5: WEIR NO. 3 STA. 114+27 AND 6'x 6'x6'
JUMP POOL STA. 114+28 PRIOR TO CONSTRUCTION**

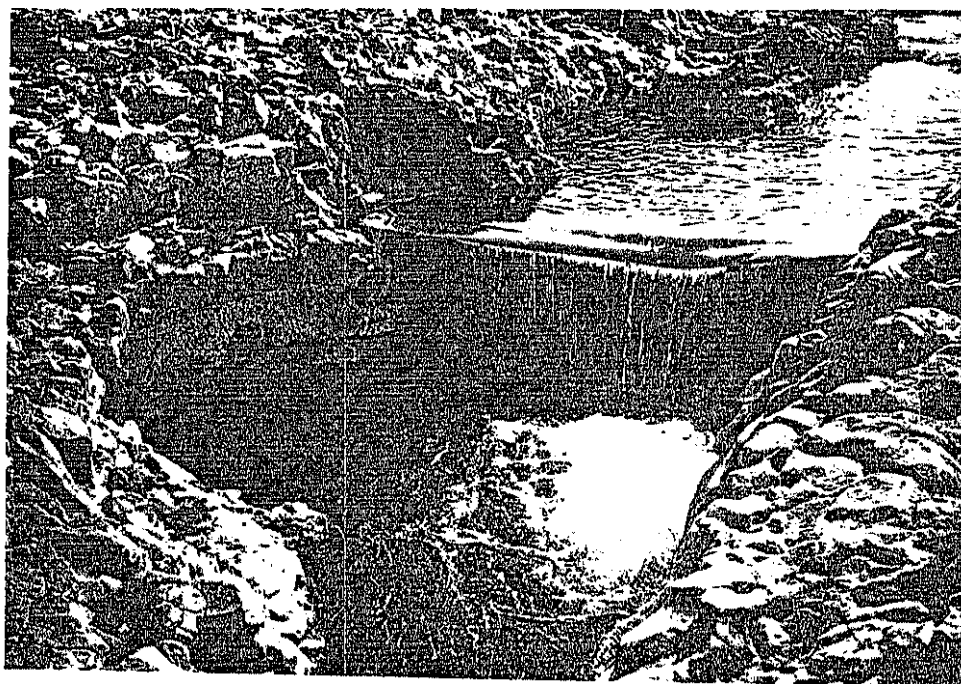
**PHOTO 6: WEIR NO. 3 AND JUMP POOL AS
CONSTRUCTED**

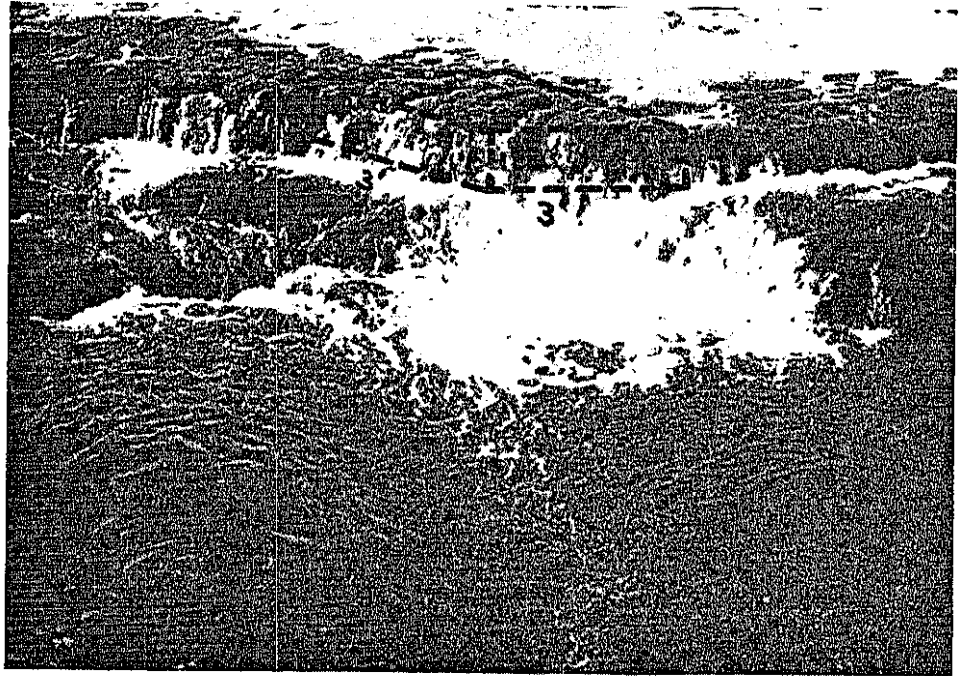
**PHOTO 7: 'REMOVE 3'x3'x1' ROCK STA. 113+50
PRIOR TO CONSTRUCTION**

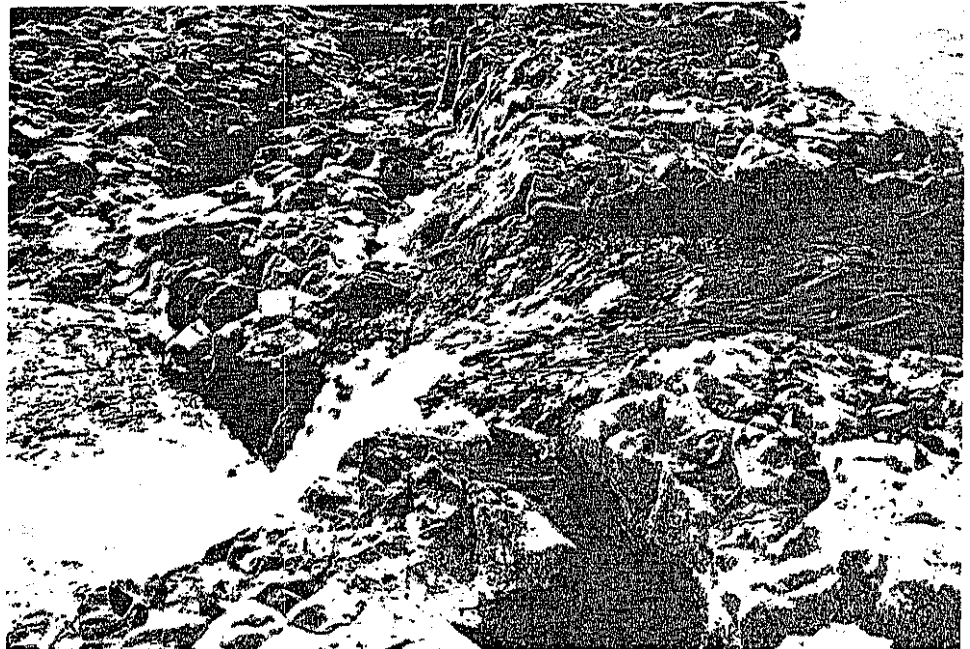
PHOTO 8: ROCK REMOVAL AS CONSTRUCTED

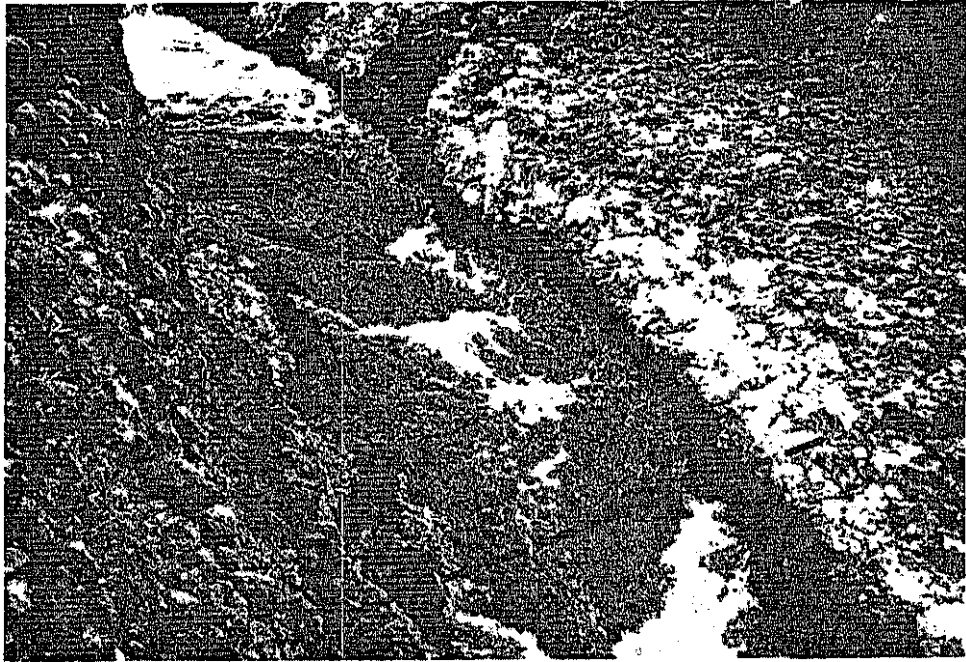
PHOTO 9: WEIR NO. 4 .STA. 108+00 PRIOR TO CONSTRUCTION

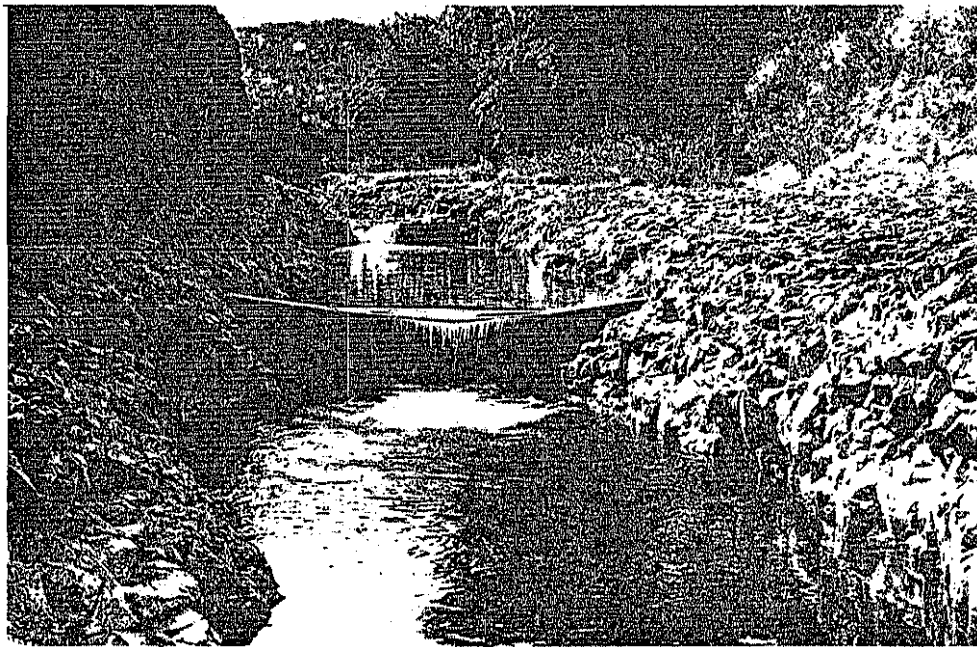
PHOTO 10: WEIR NO. 4 AS CONSTRUCTED

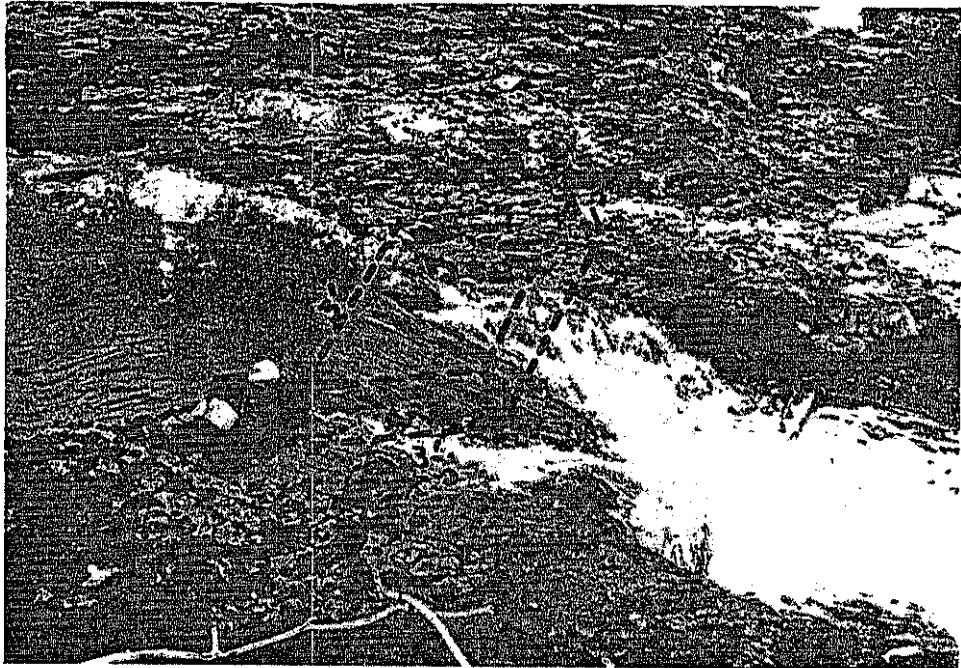
**PHOTO 11: REMOVE 3'x3'x 1' ROCK STA. 83+50
PRIOR TO CONSTRUCTION**

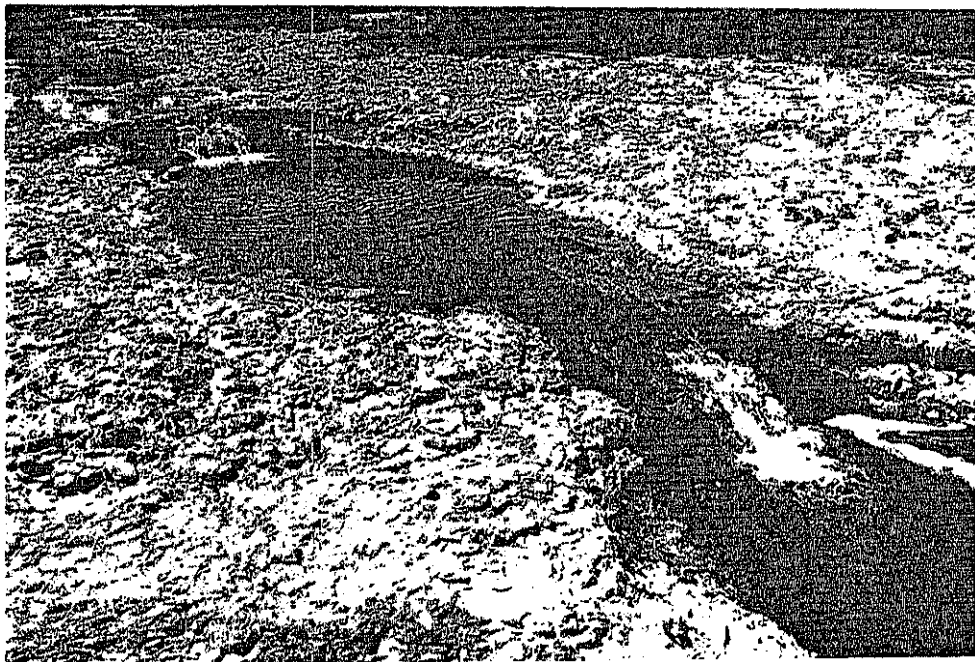
PHOTO 12: ROCK REMOVAL AS CONSTRUCTED

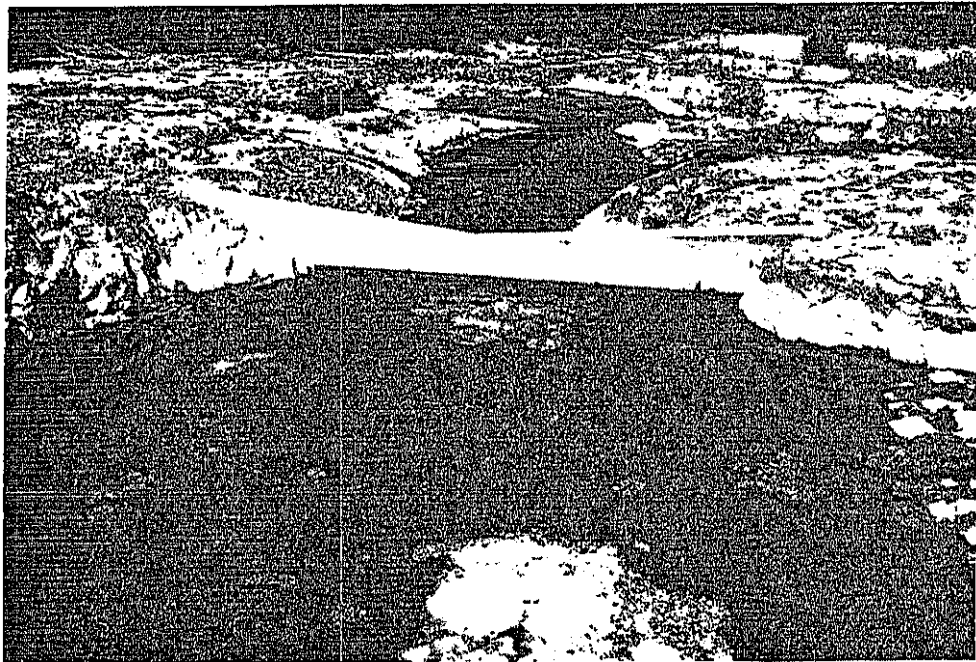
**PHOTO 14: WEIR NO., 5 AS CONSTRUCTED AND
GRAVEL REMOVED FROM CHANNEL DOWNSTREAM
OF WEIR.**

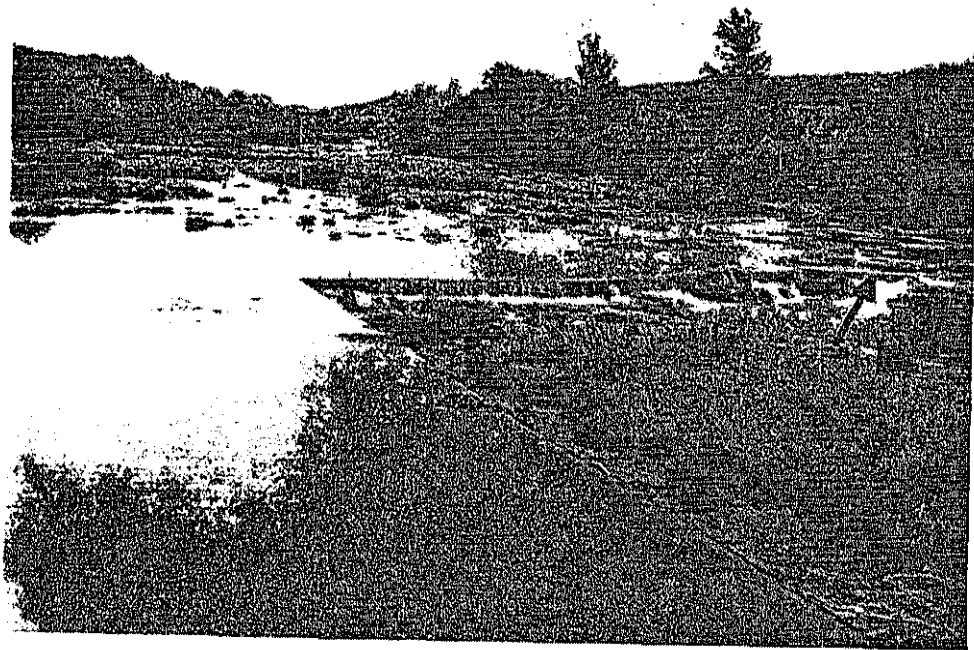
**PHOTO 15: CONSTRUCT STOP LOG STA. 80+65
PRIOR TO CONSTRUCTION**

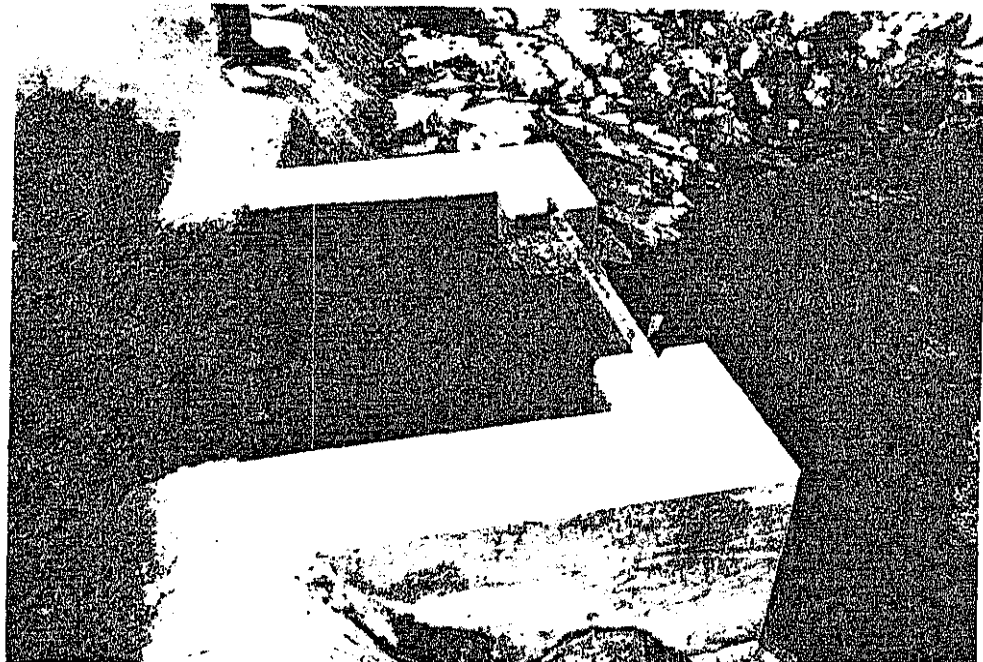
**PHOTO 16: STOP LOG STRUCTURE AS
CONSTRUCTED**

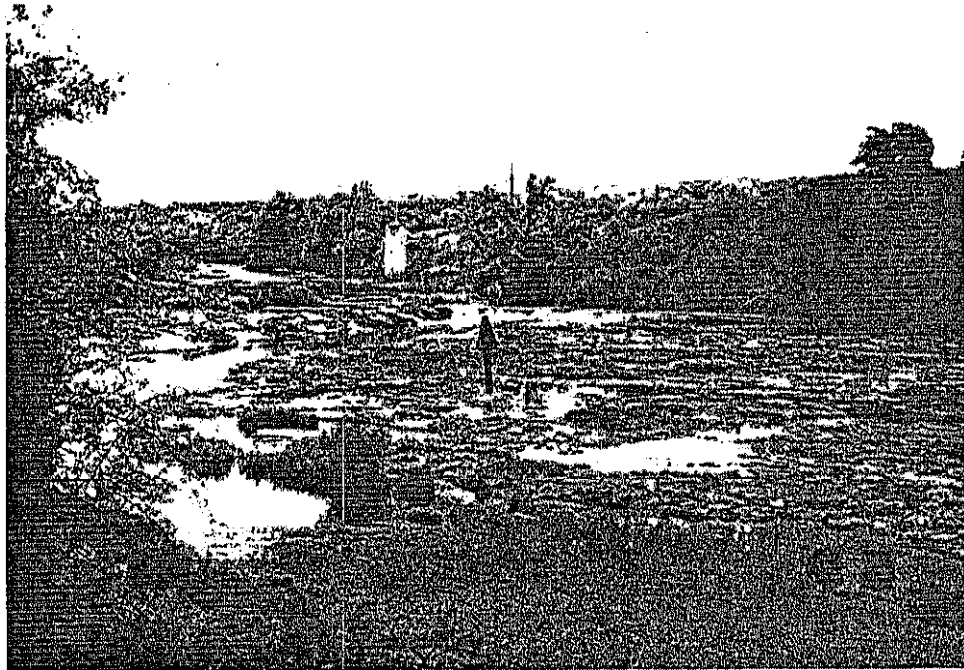
PHOTO 17: REMOVE 3'x3'x1' ROCK STA. 78~20

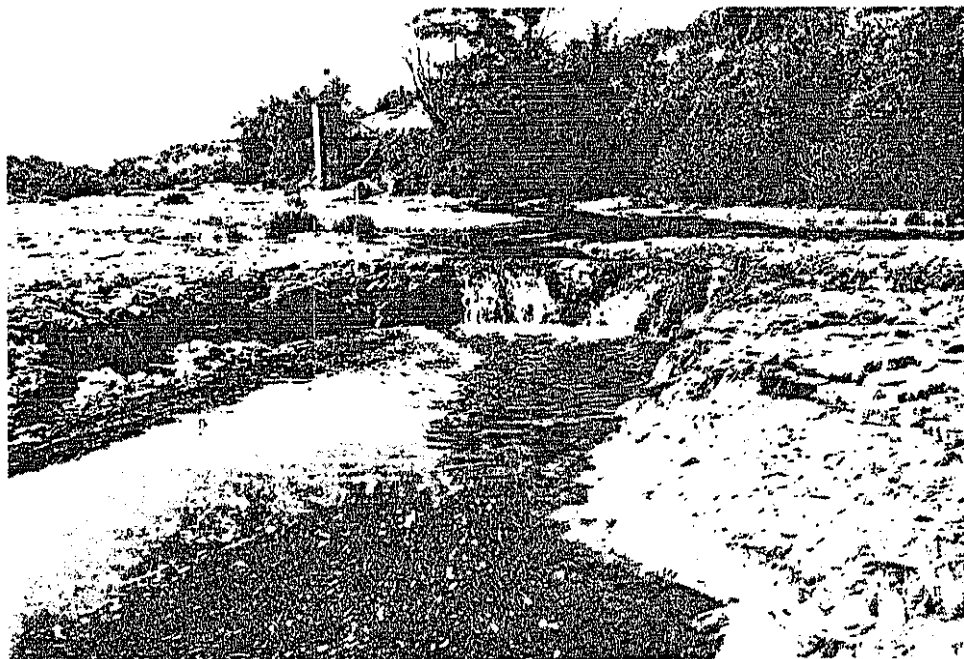
PHOTO 18: ROCK REMOVAL AS CONSTRUCTED

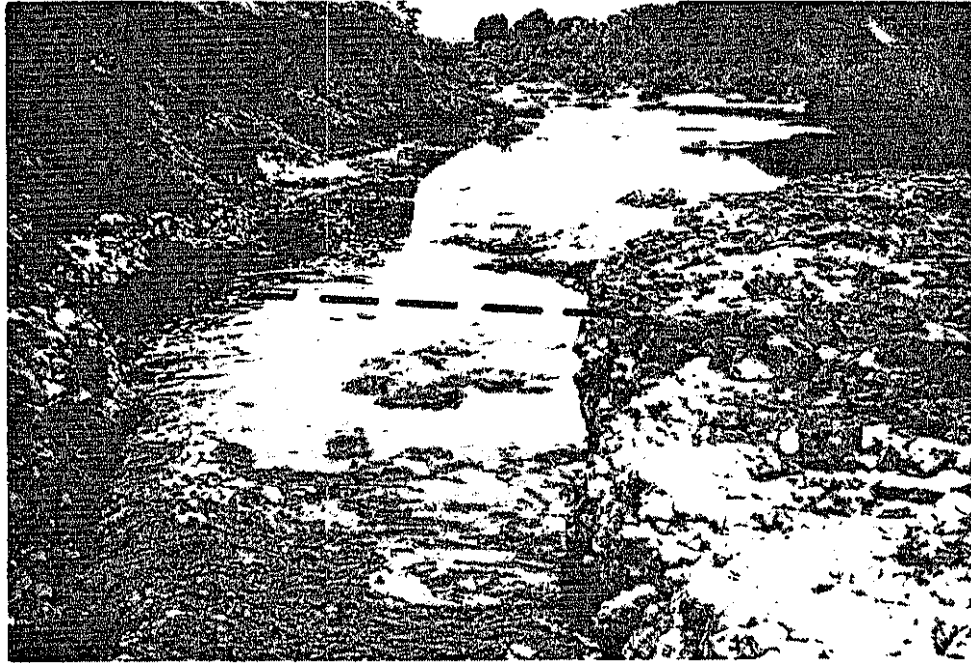
PHOTO 19: WEIR NO. 6 STA. 61+30 PRIOR TO CONSTRUCTION

Dave Carey of our Department has completed inspections of lower Umatilla River Channel Modifications below Three Mile Falls Dam as specified under Contract Number DACW68-86-M 3154. All modifications including weirs, jump pools, concrete placements, and channel excavations were done satisfactorily according to contract specifications. There is still, however, a passage problem below weir 6 (Station 61 + 30) which will require additional channel work. On October 13, when Dave Carey made final inspections, river flow was 150 cfs and the weir was creating a 5-ft drop which appeared impassable for adult salmon and steelhead. On October 15, Ray Hartlerode, ODFW Research Biologist studying adult fish passage in the Umatilla as part of the Boyd Evaluation Project, observed several adult salmon and steelhead jumping at the weir unable to pass. Approximately 130 salmon and steelhead have successfully migrated past the weir according to our trap records at Three Mile Falls Dam. We feel that these fish passed the weir at flow higher or lower than 150 cfs. At higher flows (>150 cfs), passage of adults would be possible at a side channel by the weir. At lower flows (<150 cfs) passage would be possible due to reduced velocities at the weir.

While it is uncertain if the weir is a barrier to adults, it is clear that the weir causes delay in the upstream migration of adults which is undesirable. This is especially true for fall chinook due to the short time between migration and spawning (sometimes only one month). In order to provide adequate upstream conditions for adults under all flow conditions it is recommended that 3 or 4 large boulders (3 tons/each) are placed in the pool below the weir or another weir is constructed. This will decrease the drop, reduce velocities, and increase pool depth. This work should be completed next summer prior to the start of the fall chinook migration period (September).

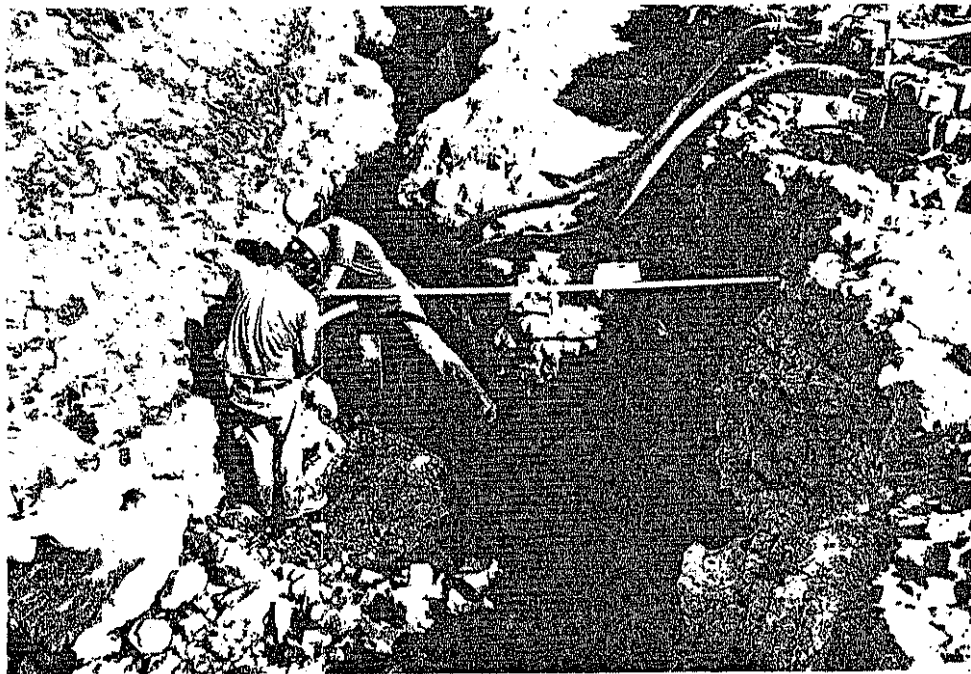
PHOTO 20: WEIR NO. 6 BEING CONSTRUCTED (SETTING STEEL)

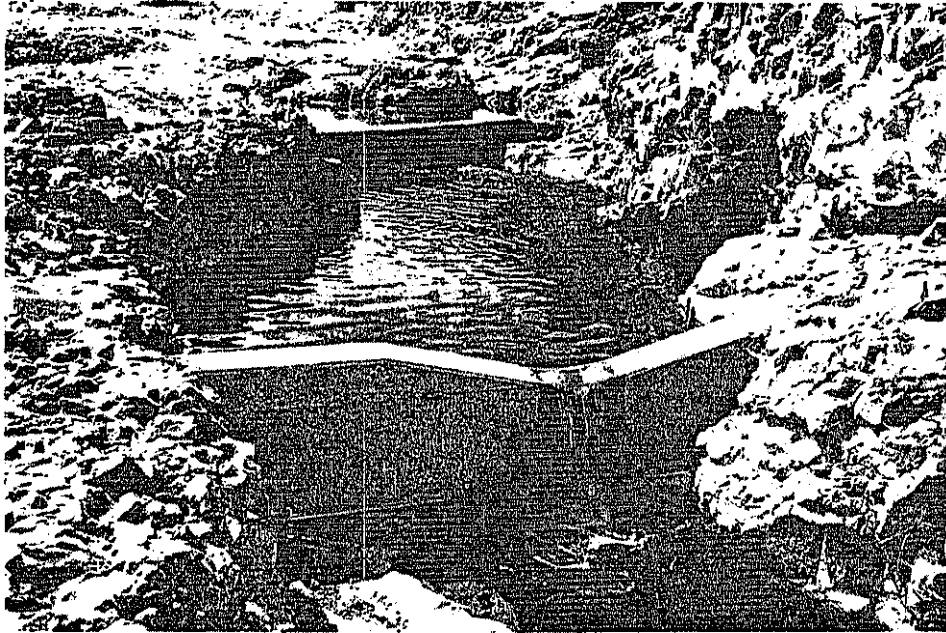
PHOTO 21: WEIR NO. 6 AS CONSTRUCTED

An inspection should be made of the entire modified channel following the high flows during the spring runoff. ODFW personnel should check the concrete weirs for any damage and the new channel should be examined for any concentrated deposits of rocks, gravel, or debris. The research data compiled by Ray Hartlerode, ODFW as part of the Boyd Evaluation Project (referenced in Appendix B) should be studied to determine if weir No. 6 is a barrier to adult fish passage.

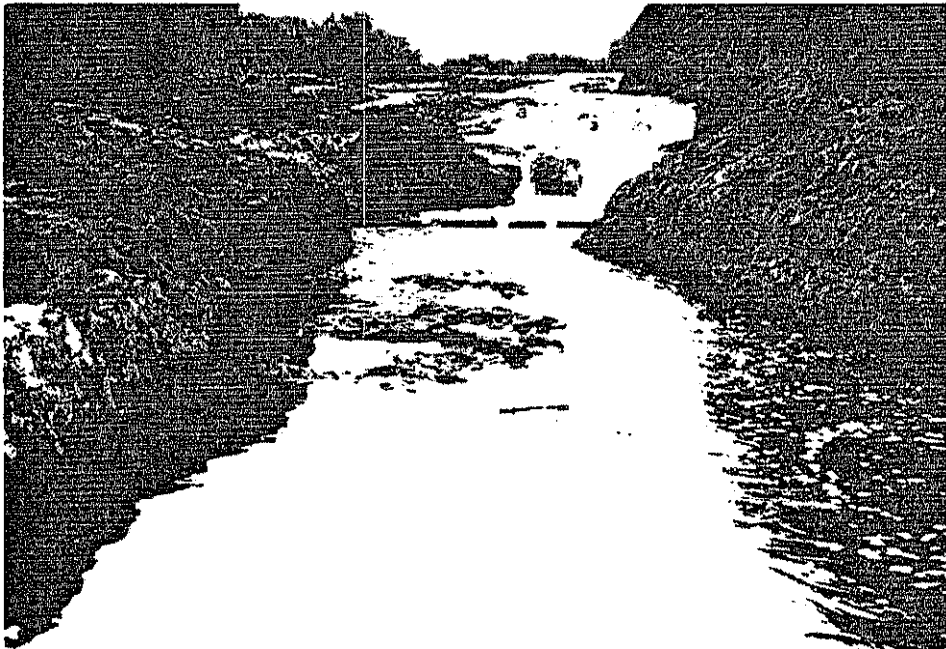
PHOTO 22: WEIR NO. 7 STA. 61+00 PRIOR TO CONSTRUCTION

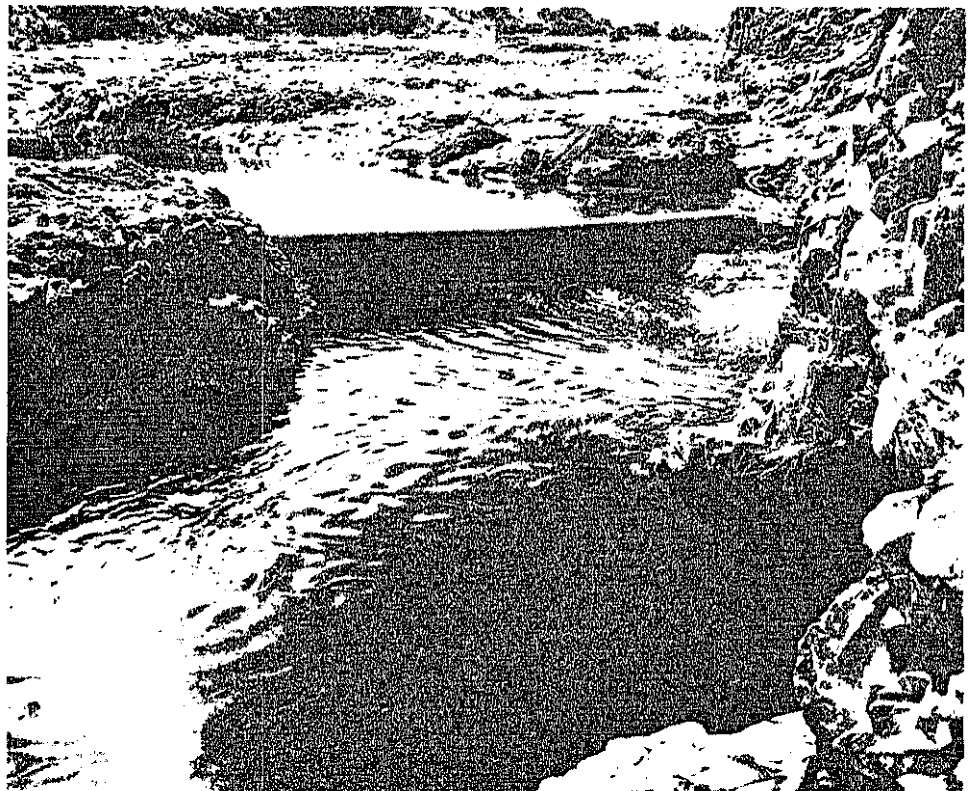
PHOTO 24: WEIR NO. 7 AS CONSTRUCTED

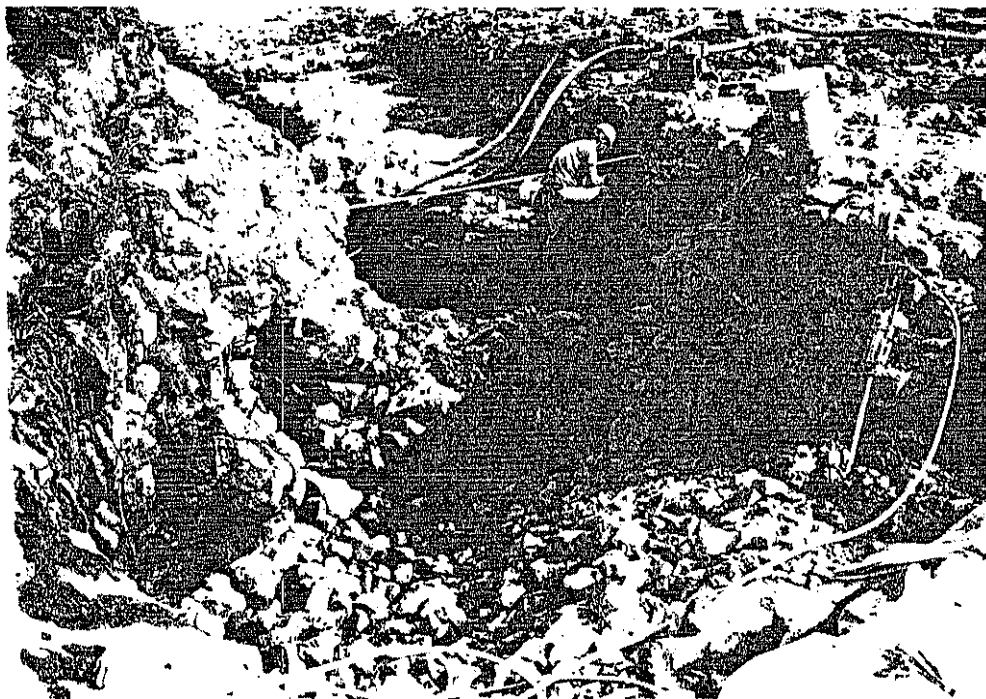
**PHOTO 26: ROCK AT STA. 60+75 WAS REMOVED
TO PROVIDE FOUNDATION FOR WEIR NO. 7**

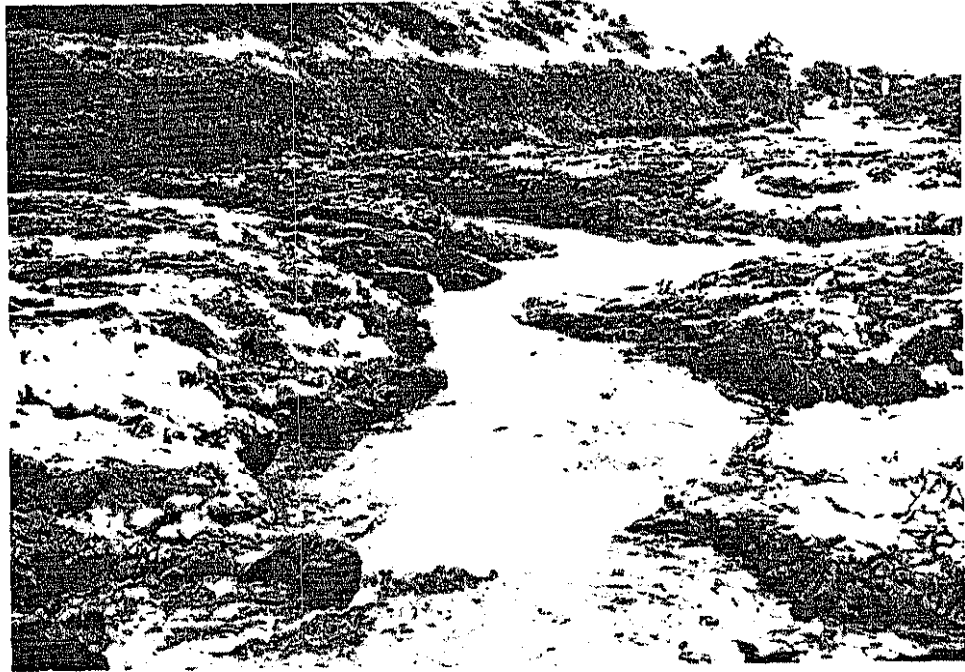
**PHOTO 27: REMOVE 3 LOOSE BOULDERS
BETWEEN STA. 60+90 TO 60+80 PRIOR TO
CONSTRUCTION**

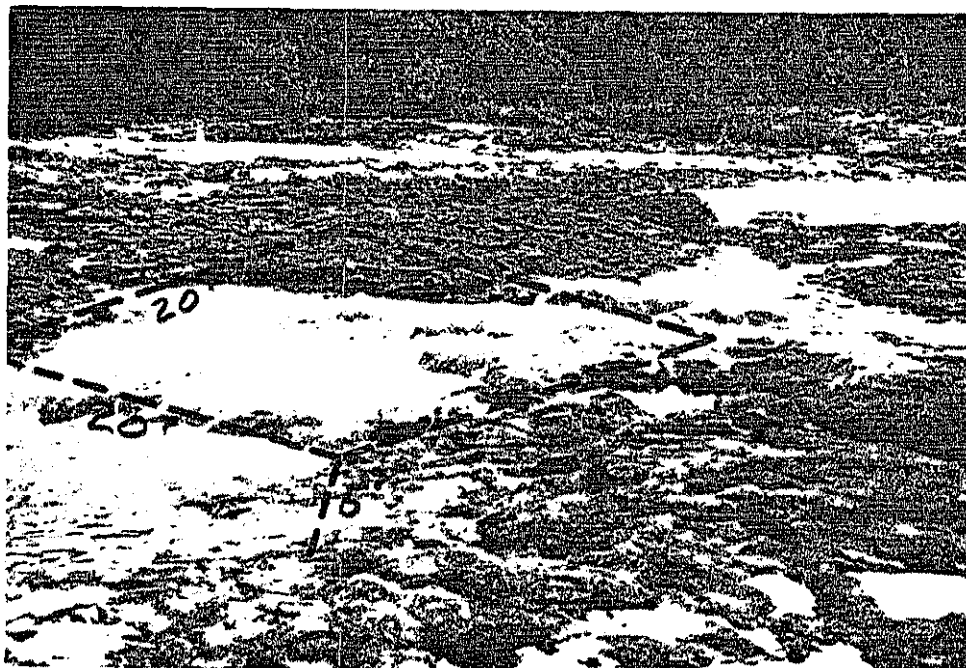
**PHOTO 30: EXCAVATE 20'x20'x5' JUMP POOL
S-T-A. 59+45 PRIOR TO CONSTRUCTION
NOTE: THE ABOVE JUMP POOLS WERE DELETED**

a. Delete the requirement for construction of jump pools at Stations 59+45, 59+85 and 114+34.

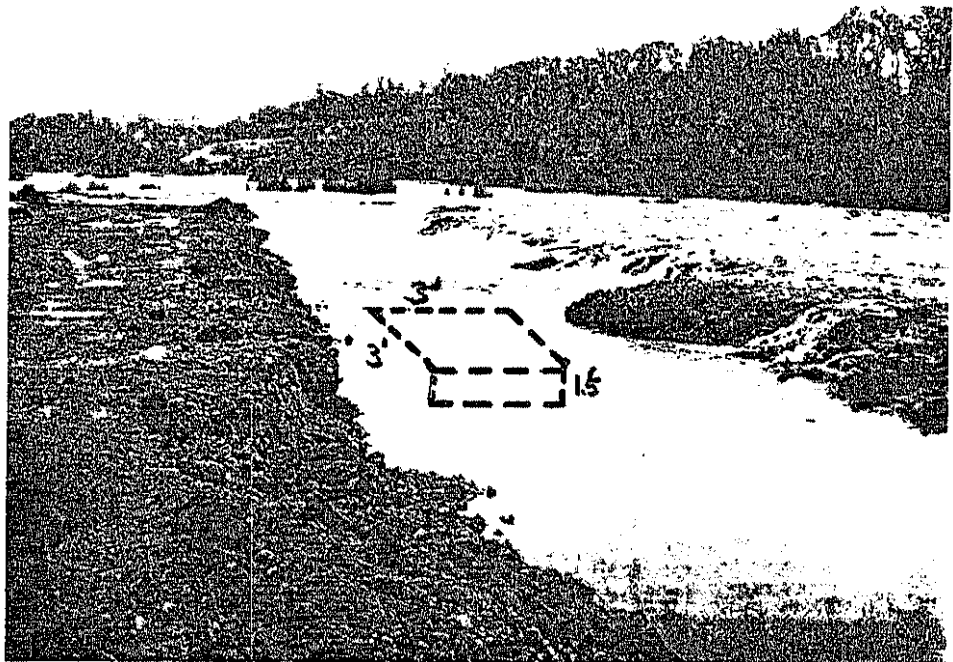
**PHOTO 31: EXCAVATE 3'x3'x1.5' ROCK
STA. 51+50**

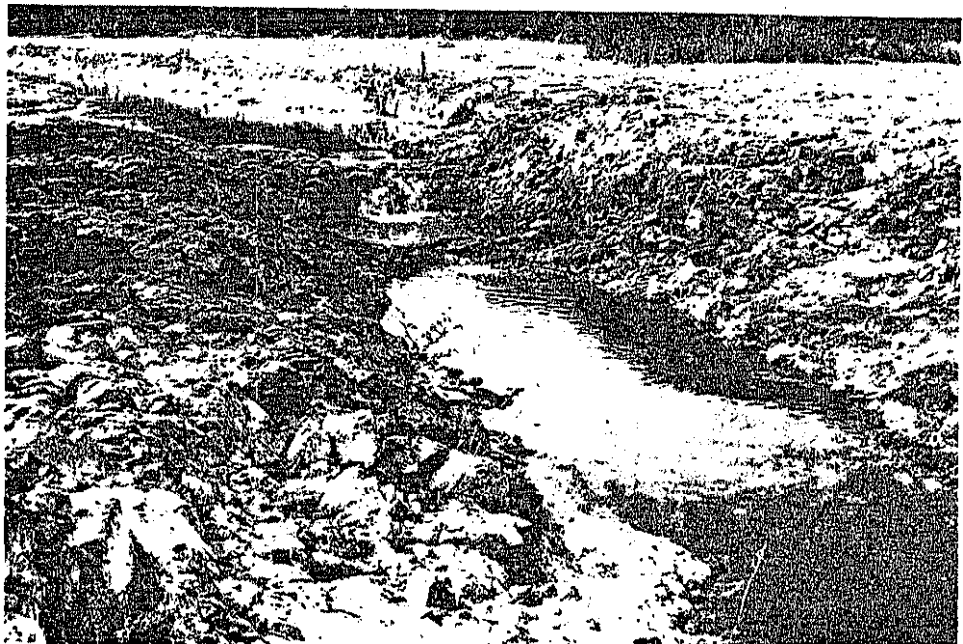
**PHOTO 32: ROCK REMOVAL AT STA. 51+50
AS CONSTRUCTED**

Two other weirs (Stations 51 + 50 and 13 t 00) may present passage problems, although no delays of fish have been observed. No additional work at these weirs is recommended at this time.

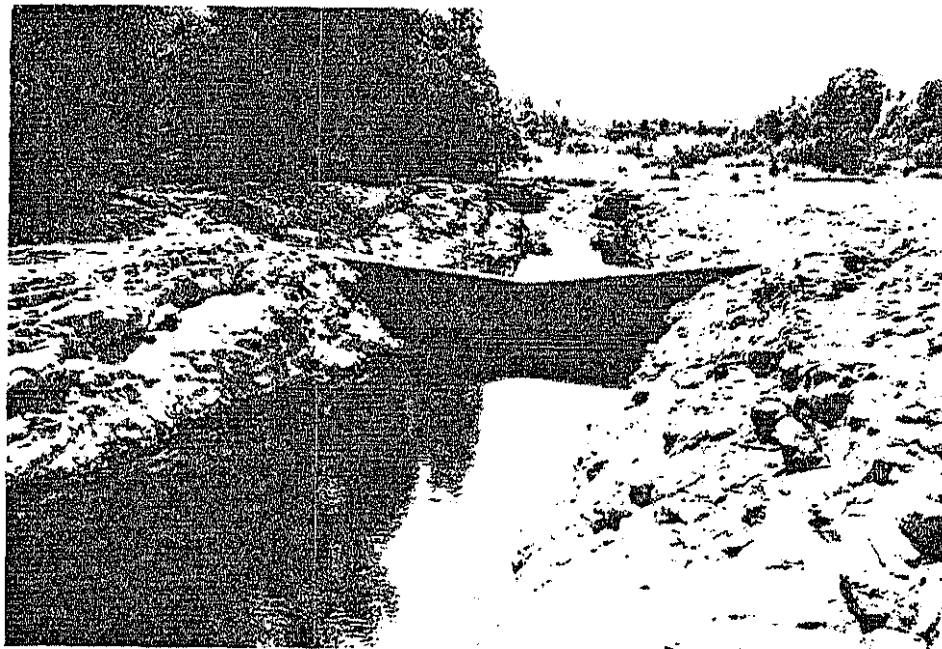
PHOTO 34: WEIR NO. 8 AS CONSTRUCTED

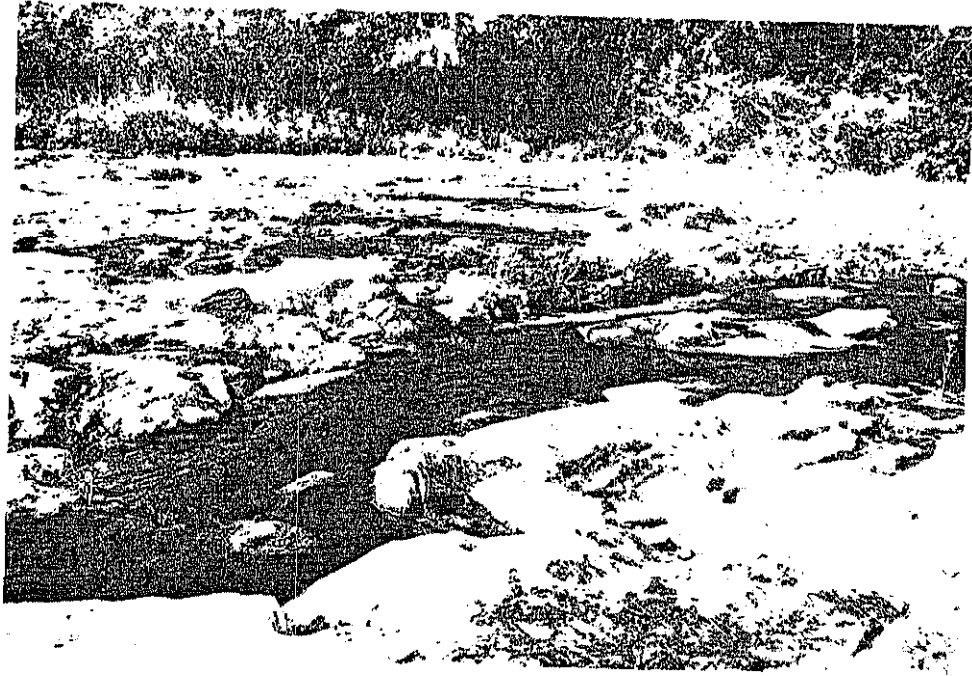
**PHOTO 35: CONCRETE PLUGS PLACED AT
STA. 46+50 TO BLOCK SIDE CHANNELS**

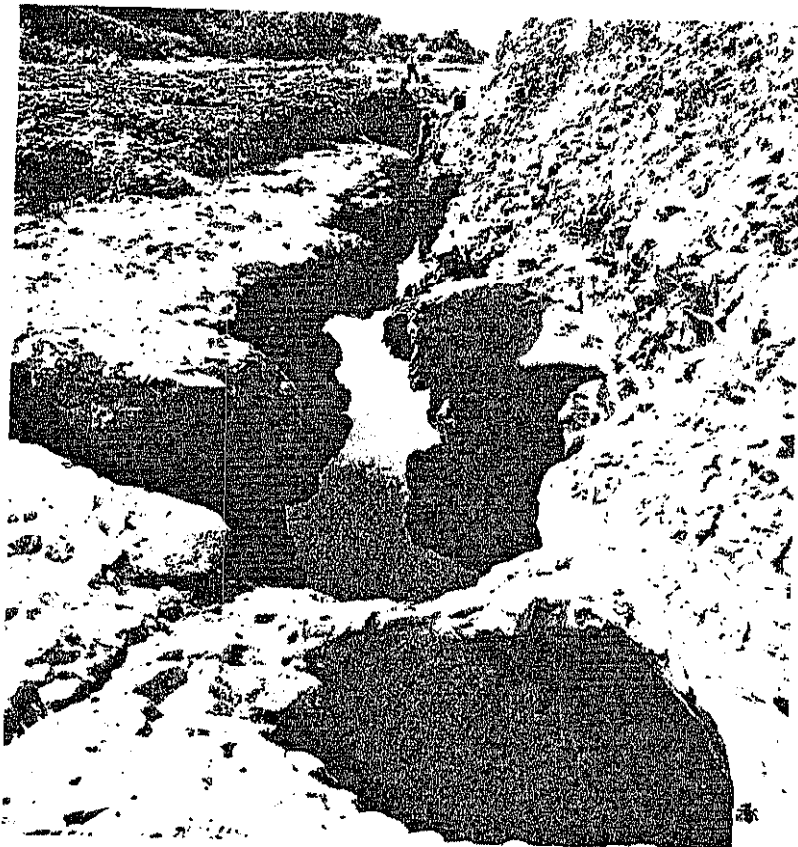
**PHOTO 36: RIVER WORN CHANNEL
BELOW WEIRS 6 AND 7.**

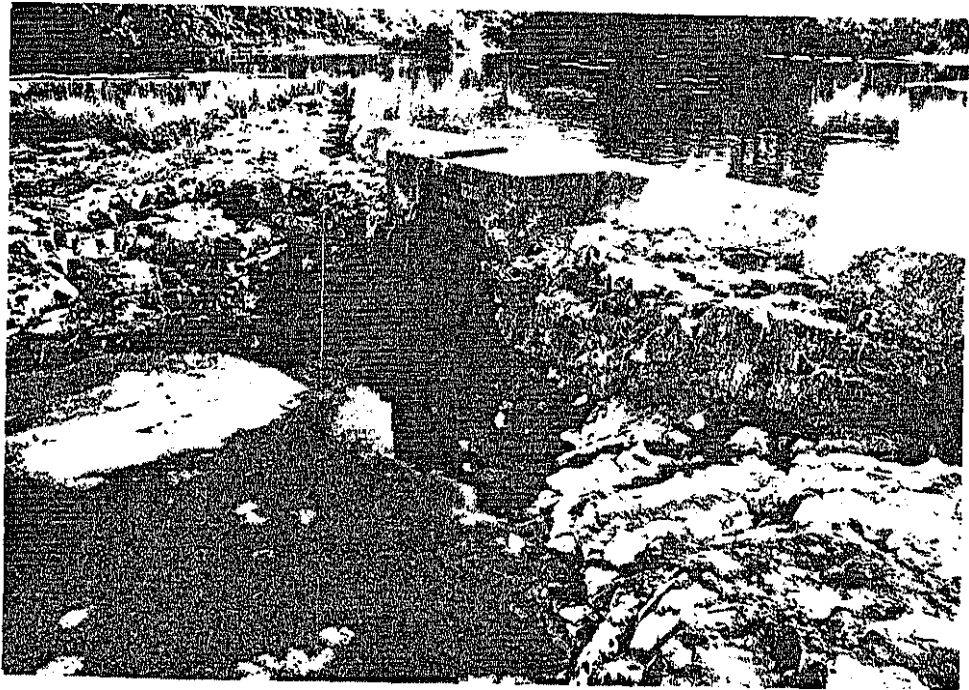
**PHOTO 37: VIEW OF STOP LOG STRUCTURE AT
BROWNELL DAM**

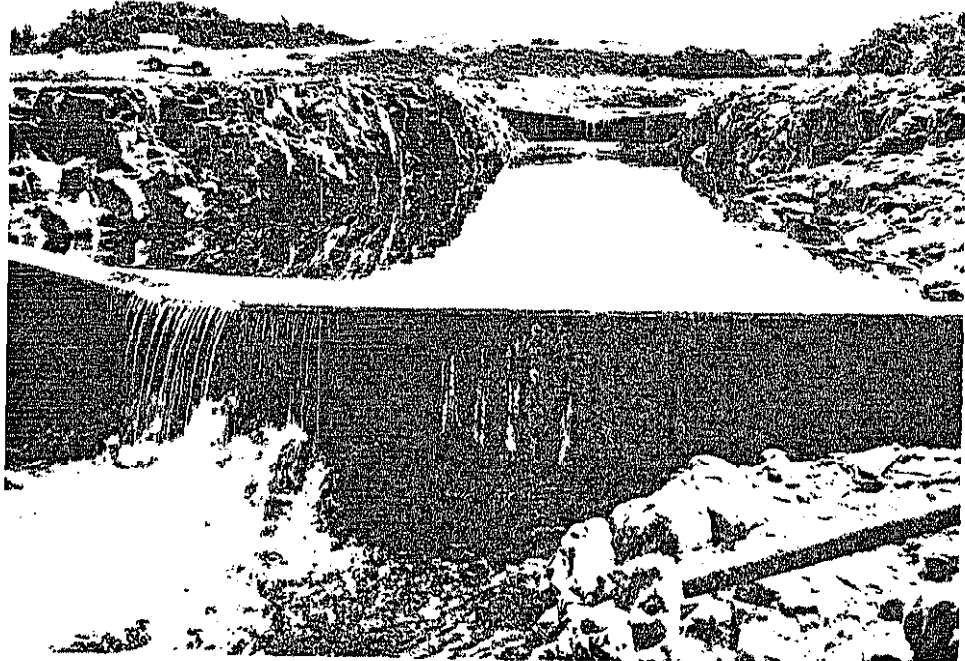
**PHOTO 38: VIEW LOOKING UPSTREAM FROM
CHINAMAN'S HOLE AT WEIRS 1 AND 2**

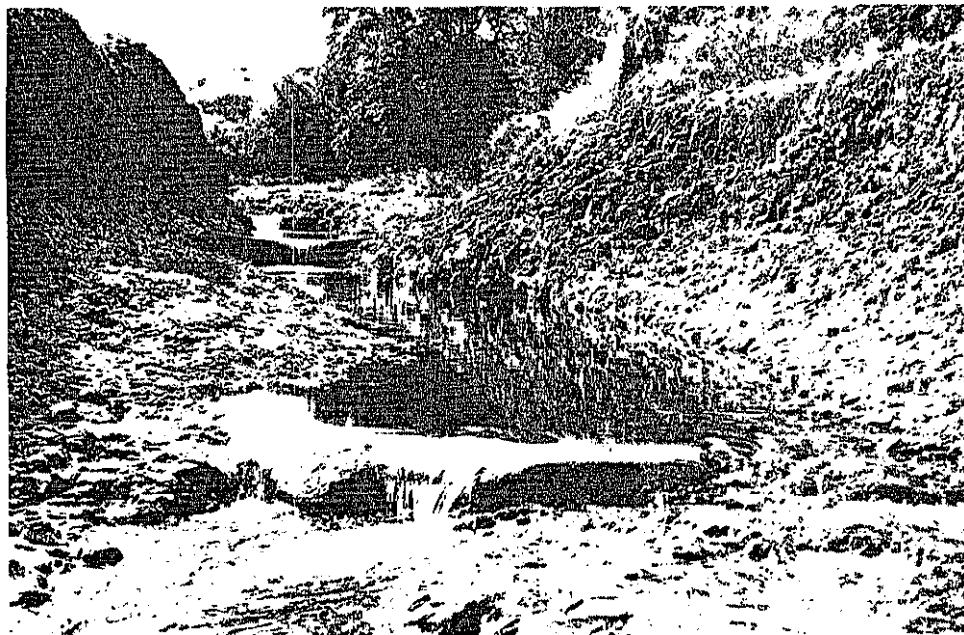
**PHOTO 40: NOTE CONCRETE FILL IN FOREGROUND
PLACED TO RAISE JUMP POOL BELOW WEIR NO. 4**

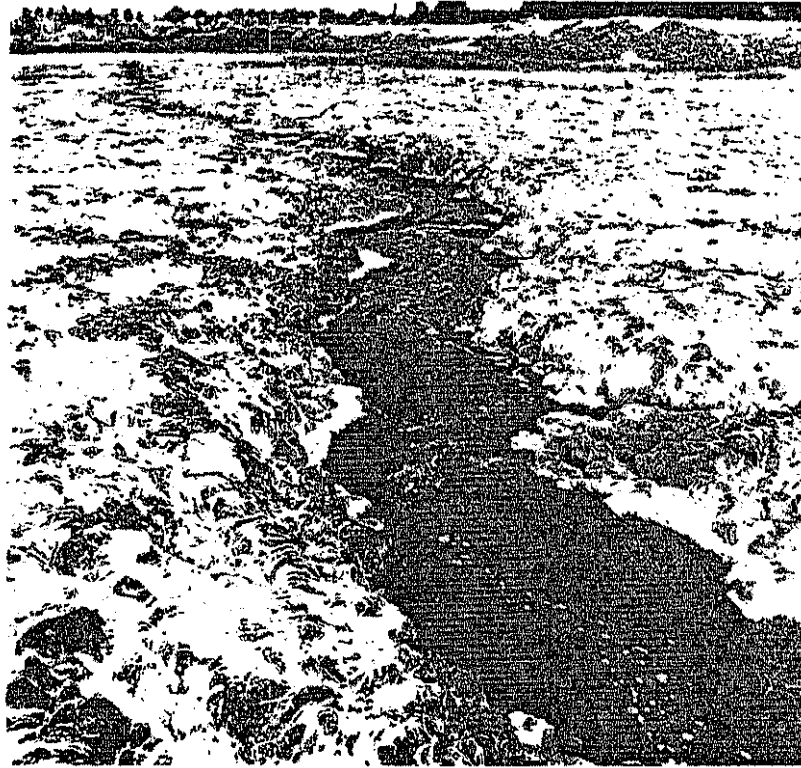
**PHOTO 41: LOOKING DOWNSTREAM FROM
STA. 98+00. THIS SECTION OF CHANNEL
WAS DEEPENED AND WIDENED WITH A HOE RAM.**

b. Provide channel improvement between approximate Stations 29+50 and 47+50 and between approximate Stations 98+00 and 100+00. Channel improvements include removal of reaches of solid rock, widening and/or deepening of existing channel, and removal of high spots and protrusions in the existing channel to provide a final minimum channel width of 3-feet wide by 1-foot deep. Channel excavation may be required at some locations to divert water into the main channel from small pools and other channels. The primary objective is to develop a channel between the above stated stations and excavation shall not be performed to divert water from side channels or pools until the Contractor has assured himself that the entire length of main channel will be excavated and the total excavation will not exceed the estimated 1,075 linear feet.

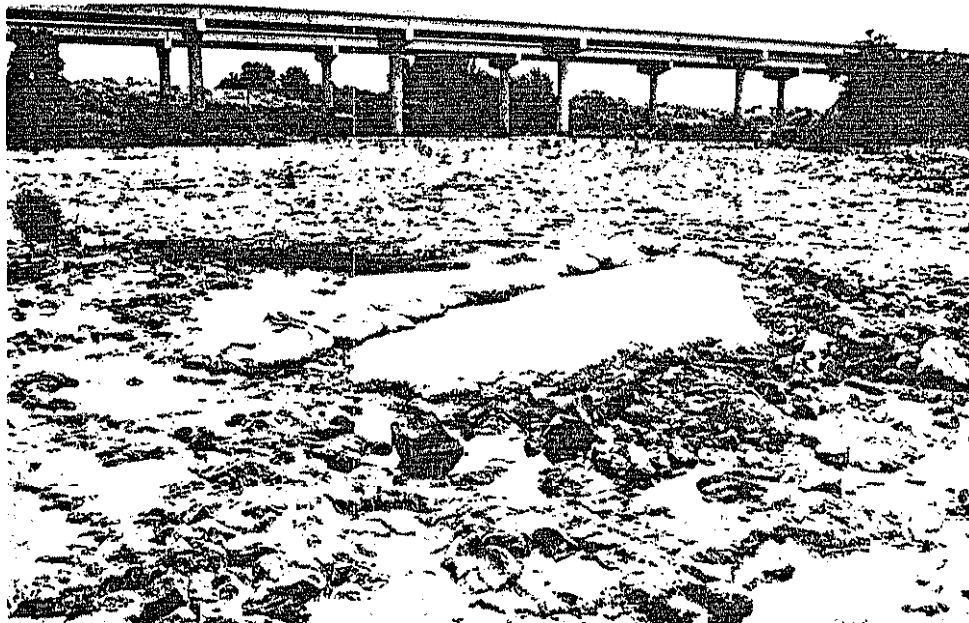
**PHOTO 42: MISCELLANEOUS CONCRETE FILL
PLACED TO BLOCK SIDE CHANNEL**
